TOYOTA AVENSIS

ELECTRONIC PARKING BRAKE SYSTEM (EPB) FAILURES

SEALED BOX - WATER INGRESS

28 February 2014

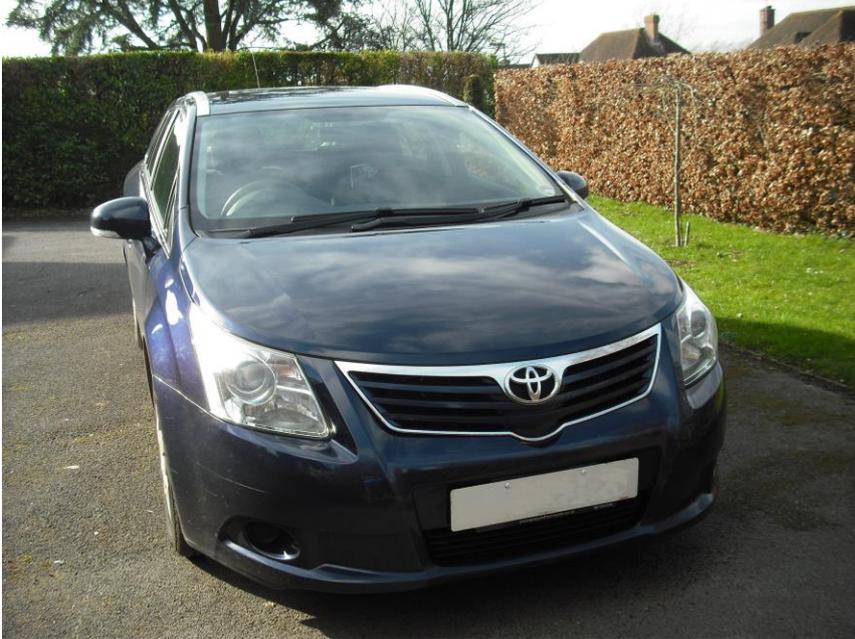
Toyota Avensis: two electric parking brake system failures in four years:

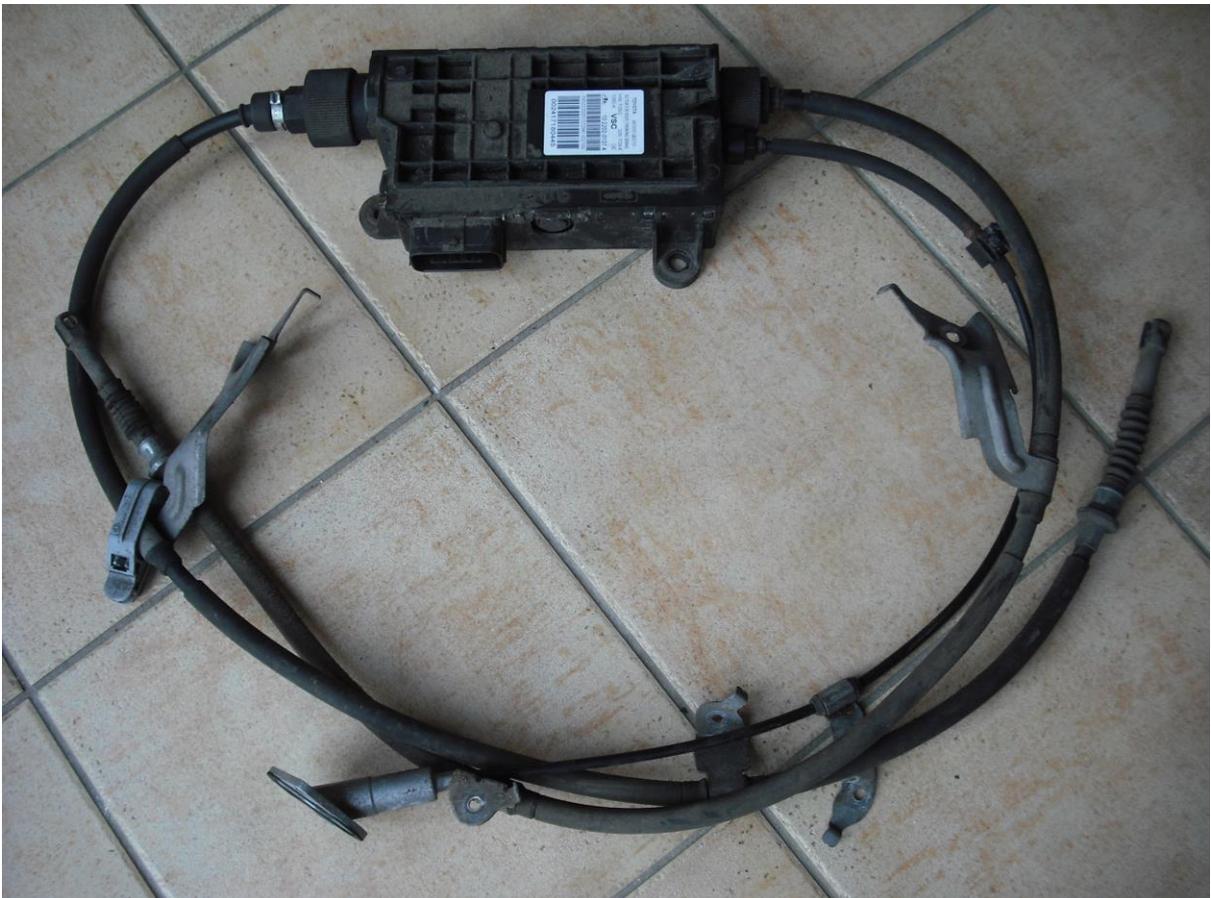
Faulty EPB removed:

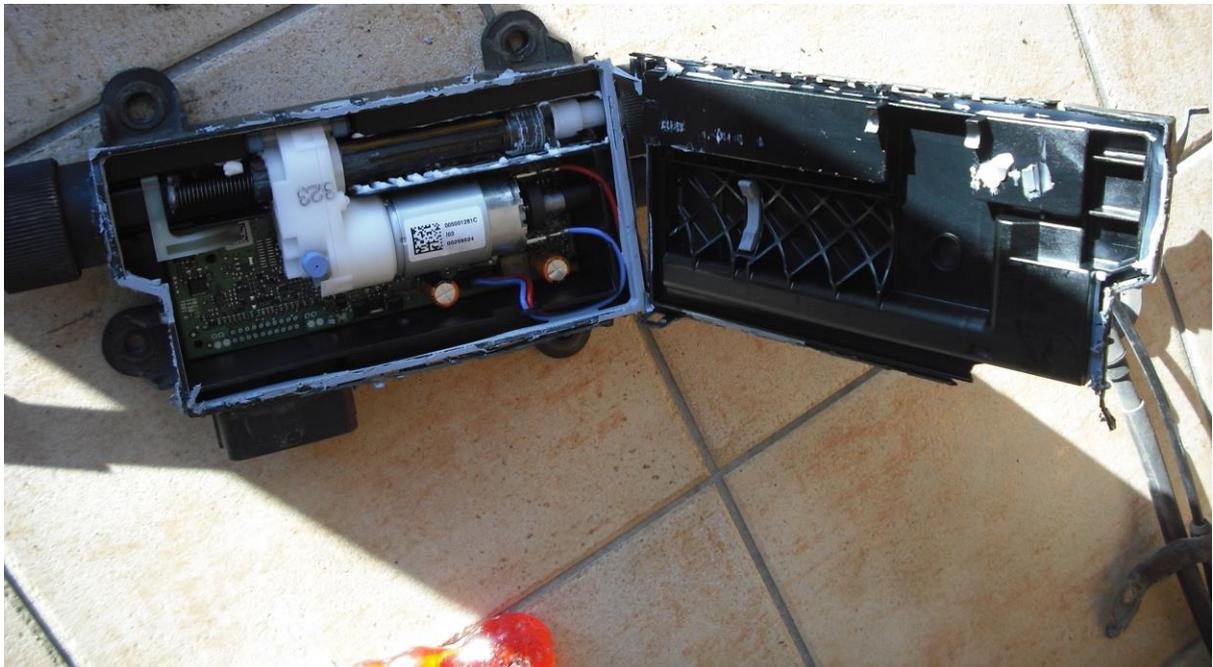
The box seal broken open:

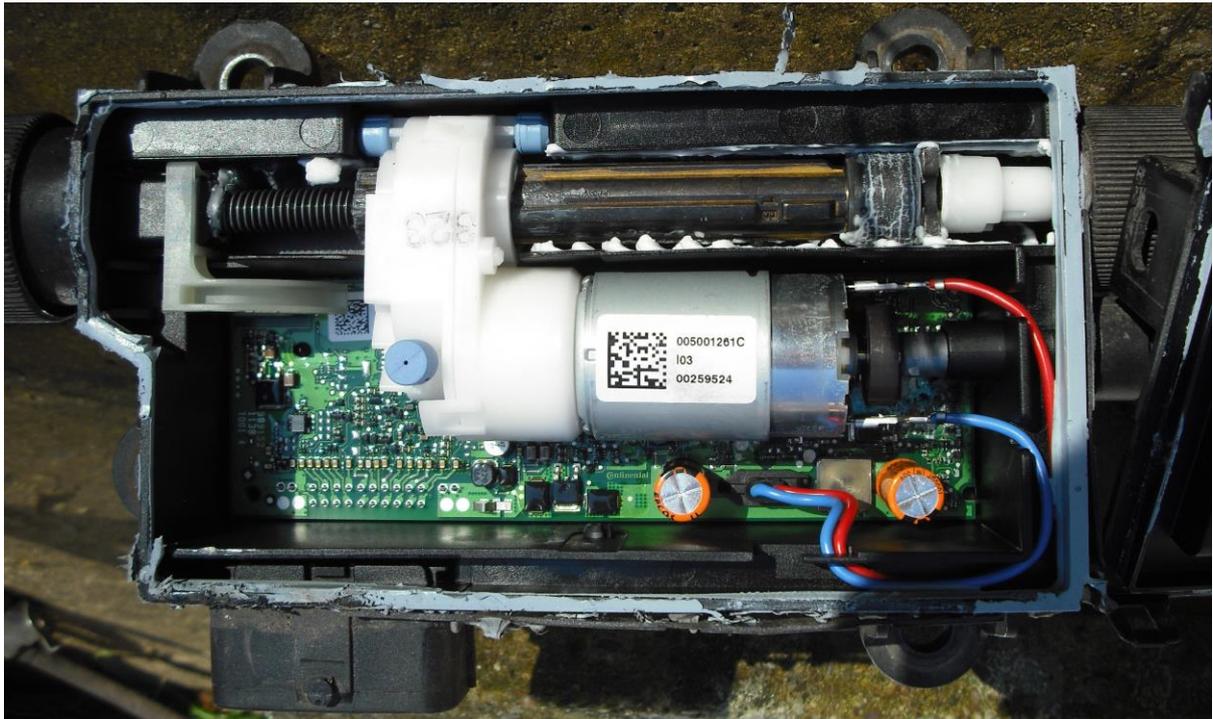
Circuit board inside with its 'Continental' logo:

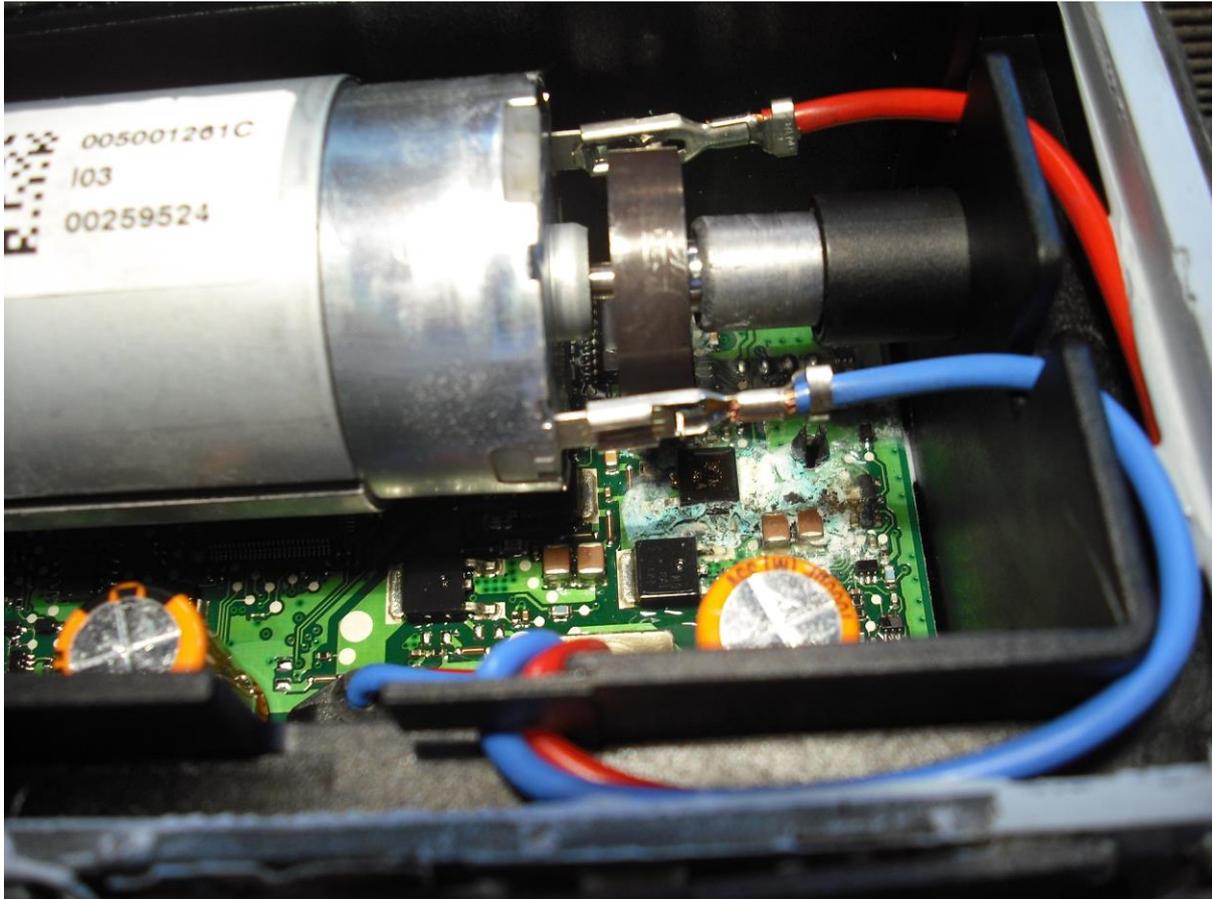
The most recently failed unit was dismantled and electrolytic corrosion found covering a 25mm patch of the circuit board.

The damage is caused by water. The location is at the rear of the motor and below the entry point of the parking brake release Bowden cable. From end to end the Bowden cable assembly is not airtight, as noted in the handbook on page 569.

Moisture in the air within the Bowden cable condenses and then drips into the EPB since the cable slopes downwards. In addition, air within the EPG box will expand when warm then contract when cold, thus creating a vacuum which sucks in water from the Bowden cable.

White corrosion salts on the circuit board below the manual parking brake release:

We design high reliability electronic systems. We neither supply nor repair automotive parts. Repair possibility: IF corrosion has not seriously damaged any circuit tracks or components then it might work after washing the board using a small paintbrush with PCB cleaner and then spraying with Electrolube contact cleaner oil to halt further corrosion. It is conceivable this could be achieved by 'keyhole surgery' through the Bowden cable hole.

- Toyota specify a hermetically sealed replacement Bowden cable assembly.
Update, April 2014: *"We are confident that the known moisture issue on the Avensis electronic parking brake system has been acknowledged and there has been a change in design of this part which has improved the seals. The design of the main box has also been improved."* – Toyota.
- Fit a threaded cap to seal the EPB's parking brake release hole properly, then cap and tie off the Bowden cable safely. Clearly, refitting would be required if manual parking brake release were ever needed.

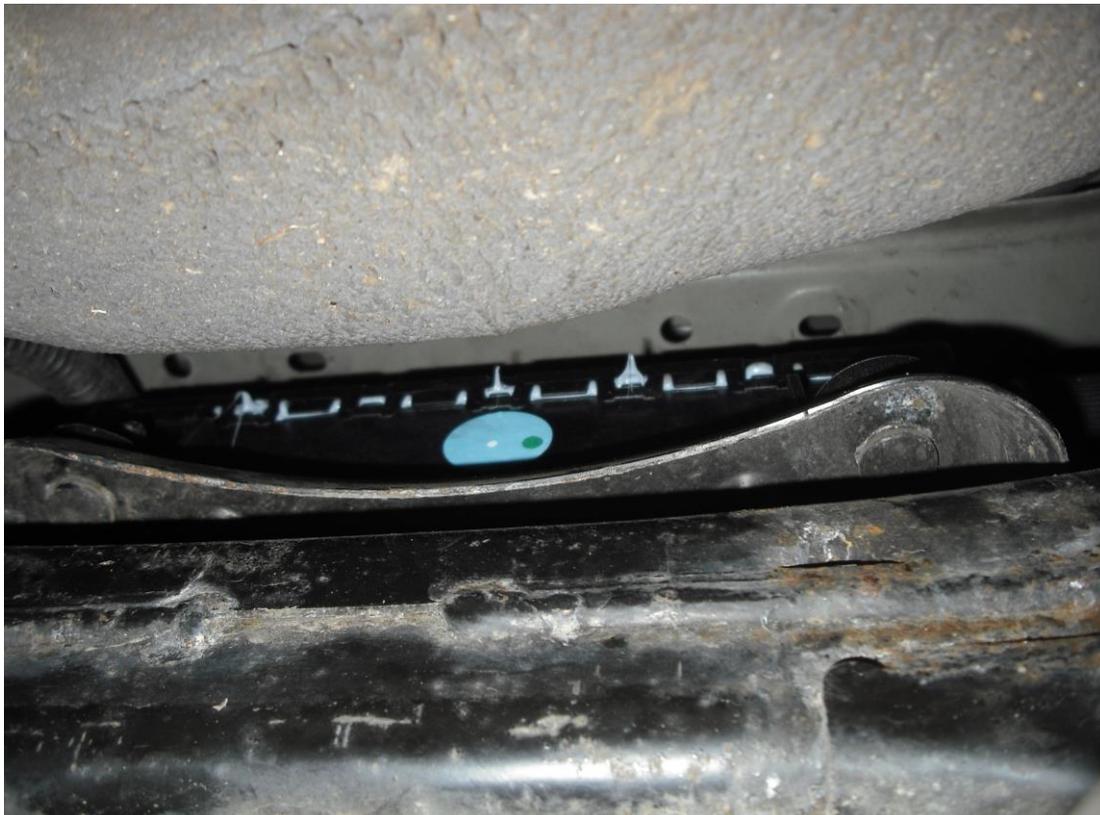
Electronic Parking Brake mounted above a strut between the rear wheels:

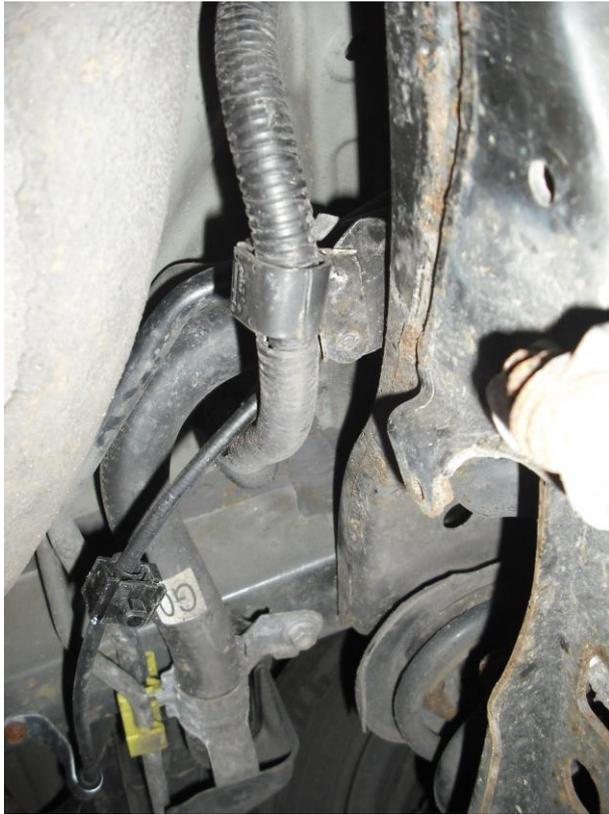
Manual parking brake release Bowden cable descending from the rear boot area:

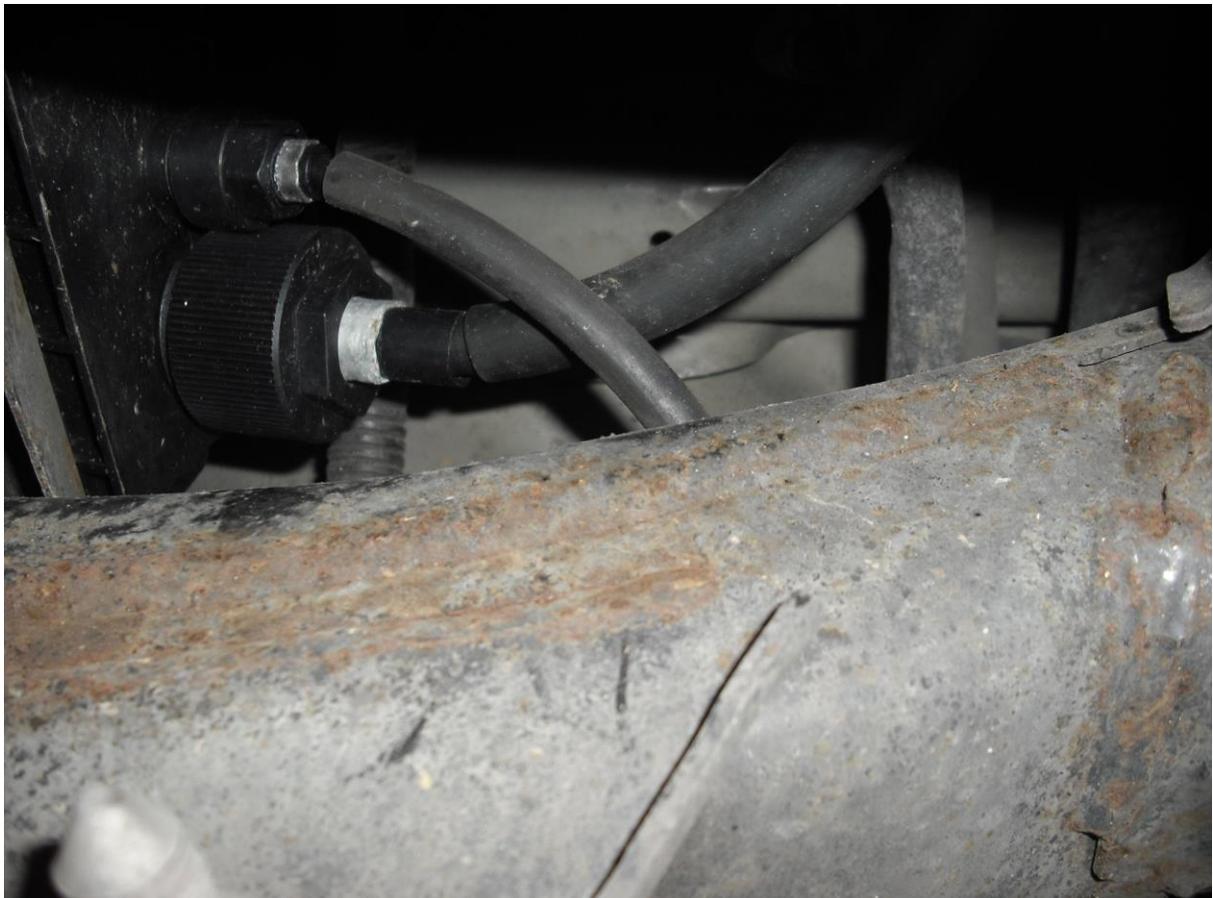
Parking brake release Bowden cable and a brake actuator connected to the EPB:

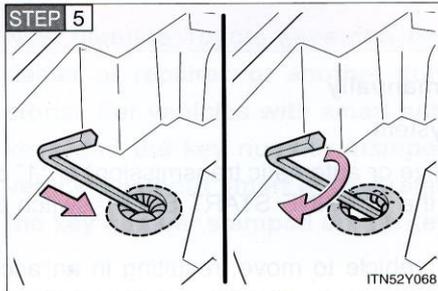
5-2. Steps to take in an emergency

The manual notes how a missing or damaged seal could allow standing water to flow into the parking brake release and consequently require EPB replacement:

If the trunk has flooded with water when the seal has been broken or is missing (for example, if the vehicle has been left outside in the rain with the trunk lid open or removed), the parking brake system will need to be replaced.

The seal needs to be replaced by any authorized Toyota dealer or repairer, or another duly qualified and equipped professional.
