TOYOTA AVENSIS

ELECTRONIC PARKING BRAKE SYSTEM (EPB) FAILURES

SEALED BOX - WATER INGRESS

28 February 2014

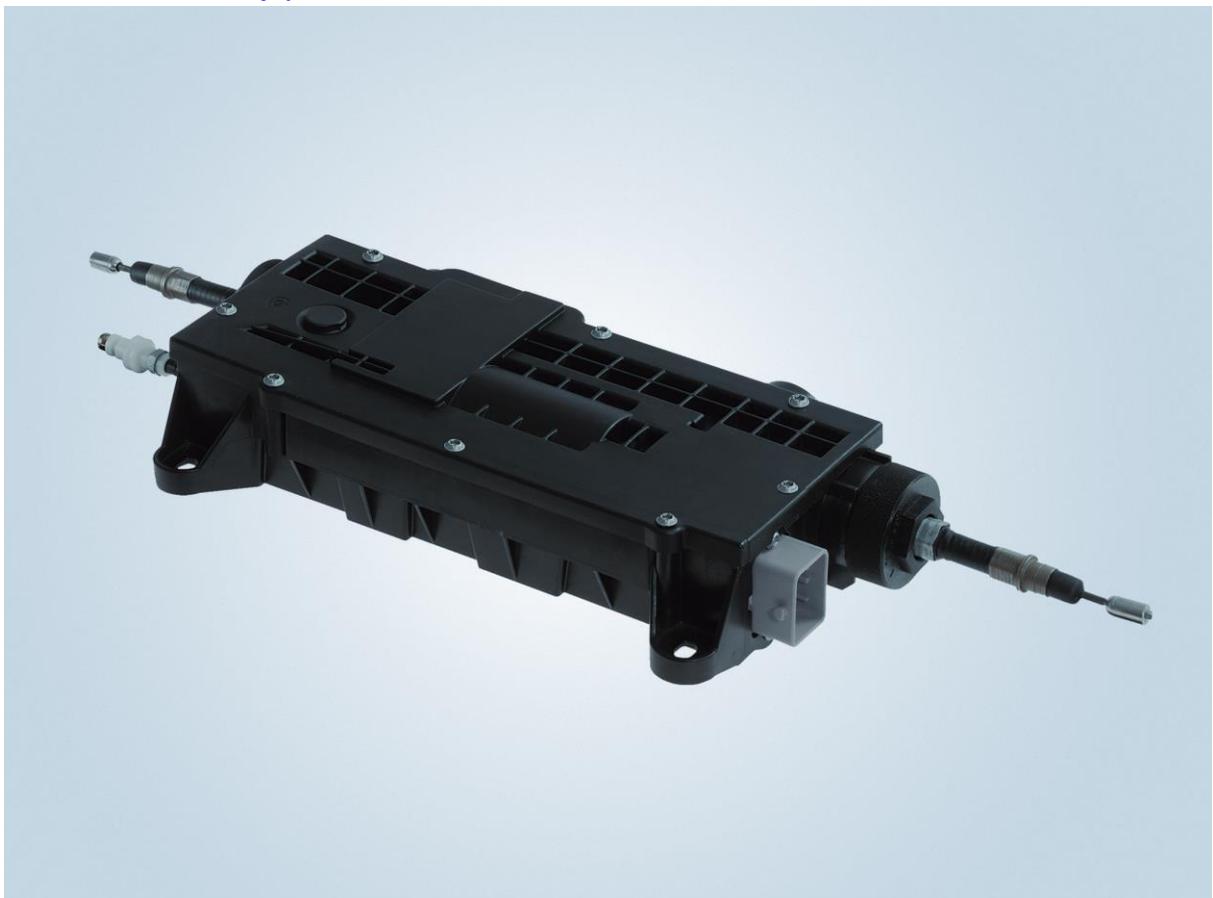
The most recently failed unit was dismantled and electrolytic corrosion found covering a 25mm patch of the circuit board.

The damage is caused by water. The location is at the rear of the motor and below the entry point of the parking brake release Bowden cable. From end to end the Bowden cable assembly is not airtight, as noted in the handbook on page 569.

Moisture in the air within the Bowden cable condenses and then drips into the EPB since the cable slopes downwards. In addition, air within the EPG box will expand when warm then contract when cold, thus creating a vacuum which sucks in water from the Bowden cable.

Variant of the Continental 129889_en:
